**FATIGUE BEHAVIOR OF A SiC/SiC COMPOSITE AT 1000 °C IN AIR AND STEAM**

**THESIS**

Knauf, Michael, Captain, USAF  
AFIT/GAE/ENY/10-D01

**AIR FORCE INSTITUTE OF TECHNOLOGY**

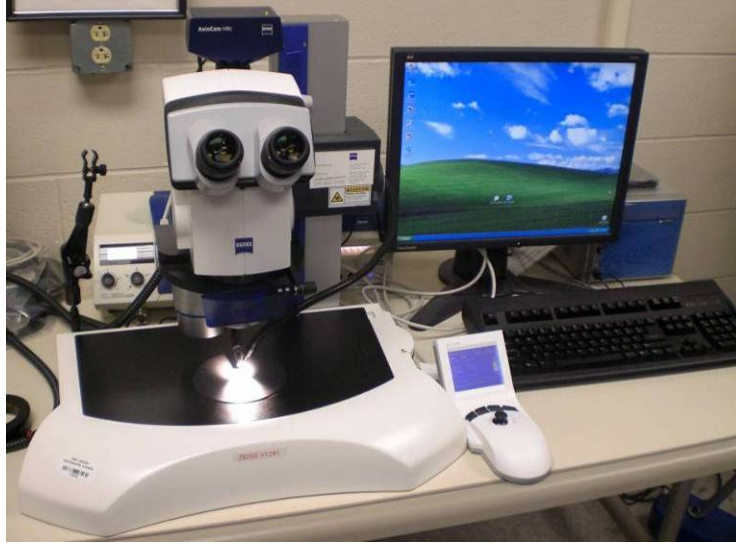
Following failure, each test specimen was marked T (for “top”) or B (for “bottom”) and carefully organized to ensure no damage would occur to the fracture surface. The sides of each half were then photographed under a Zeiss stereomicroscope shown in Figure 7. Fracture surfaces of one of the halves of each specimen were subsequently cut off with a diamond blade and mounted on SEM pin mounts. Additional material from the same half was then cut and mounted into conductive 1 ¼” phenolic pucks (Buehler number 20-3112-501) using a Buehler SimpliMet 2000. These were then polished according to the suggested polishing guide for SiC/SiC ceramic matrix composites [10:231] using a Buehler EcoMet/AutoMet 300. The process is outlined in Table 2,

**Figure 7: Zeiss Stereomicroscope used in microstructural examination**

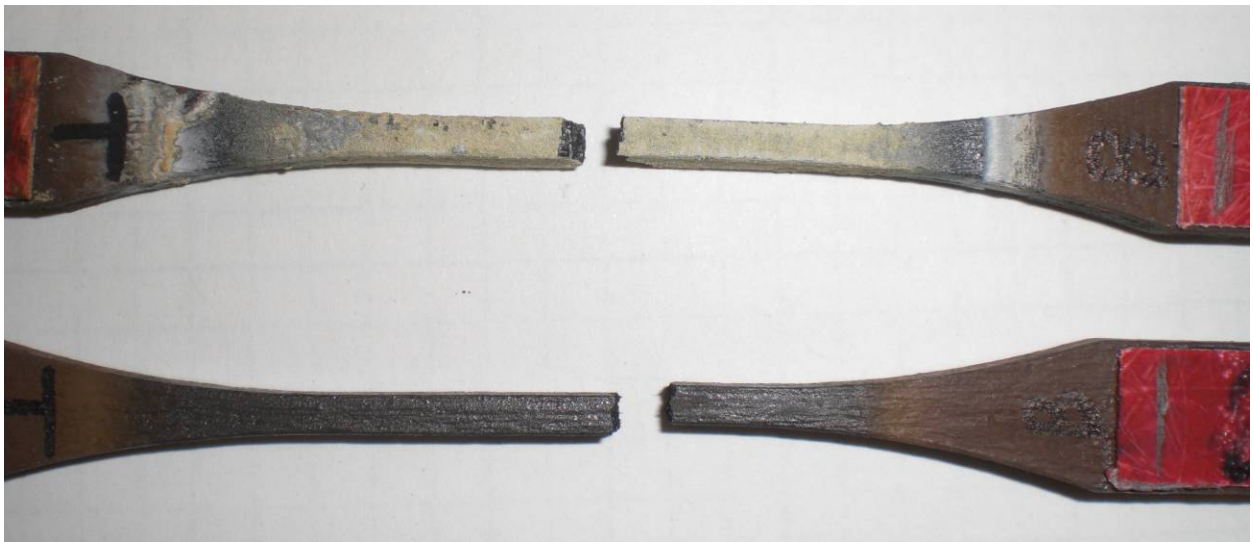
One of the most remarkable features of the specimens tested in steam is through-thickness swelling of the test section. Note that this effect was not observed for specimens tested in air. Figure 25 shows specimen S11A subjected to the 60 MPa test at 1000 °C in steam, which failed after 194,930 cycles. The dotted line marks the initial thickness of the specimen, making through-thickness swelling caused by testing at 1000 °C in steam readily apparent. A specimen tested in fatigue at 1000 °C in air is shown nearby for comparison. Note that the specimen tested in air exhibits no through-thickness swelling. Additionally, specimens tested in steam and air exhibited very little change in width (see Figure 26).

**Figure 26: Front view of specimens tested in fatigue at 1000 °C in steam (top) and in air (bottom) showing no swelling regardless of test environment.**

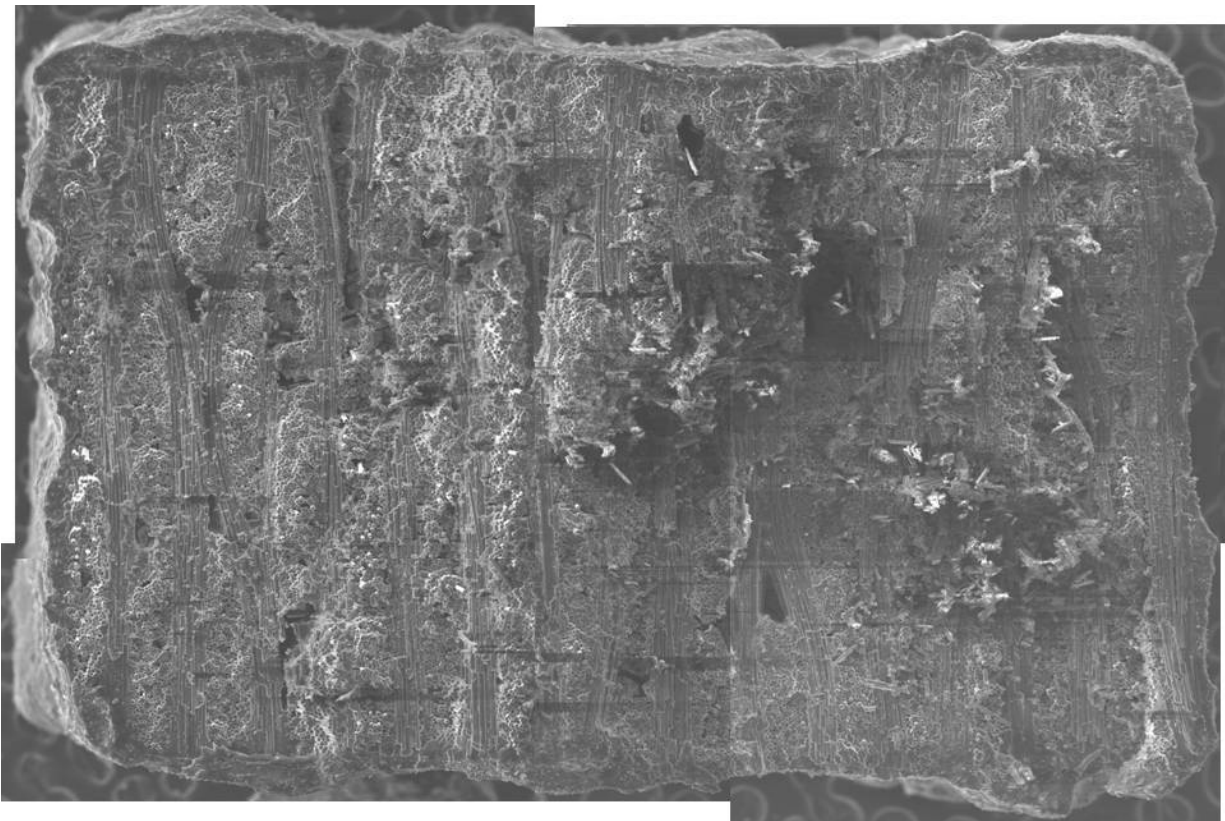
Specimen S5A, which exhibited the lowest UTS, produced a rather jagged fracture surface with some fiber pullout as seen in the optical micrographs in Figure 33. A composite image in Figure 34 shows an appreciable amount of fiber pullout with no obvious signs of oxidation. Entire tows can be seen pulling out of the fracture surface in Figure 34. Fiber pullout can also be seen in higher magnification SEM micrographs in Figures 35 A and B. Figure 35 C shows an area of brittle fracture evidenced by coordinated fiber failure. Figure 35 D shows matrix cracking around fibers, suggesting that the matrix was weak.

**Figure 34: Optical micrographs of specimen S5A, front (A) and side (B), subjected to tensile test to failure at 1000 °C in air. Fracture surface normal to the applied load. (UTS = 98.6 MPa, E = 42.2 GPa).**

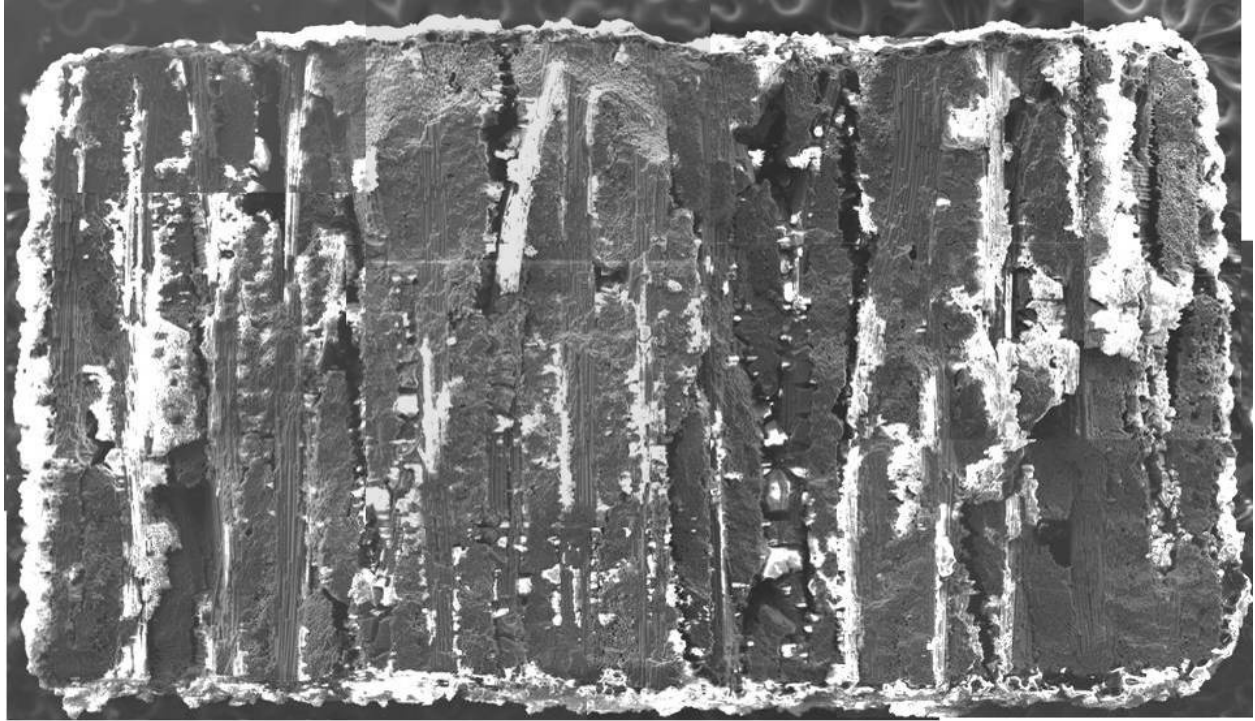
**Figure 64:** SEM composite micrograph of specimen S10E subjected to fatigue at 1000 °C in steam ( $f = 1.0$  Hz,  $\sigma_{\max} = 70$  MPa,  $N_f = 126,593$ ). Fracture surface normal to the applied load.

Figures 63-65 show the fracture surface of specimen S10E, which survived 126,593 fatigue cycles performed with the maximum stress of 70 MPa. The optical micrographs in Figure 63 reveal a great deal of white residue on the specimen surface as well as the stepwise fracture surface. However, although the fracture surface has a stepwise nature, it is mostly flat within each individual step. Figure 64 shows a fracture surface that is similar to that obtained for specimen S11A fatigued with the maximum stress of 60 MPa. Note ply delamination with large gaps opening between individual plies, creating pathways for the oxidizing environment to enter the interior of the composite. Figures 65 A and B illustrate the extent of degradation by oxidation throughout the composite where non-oxidized sections were incredibly difficult to locate. Figure 65 C demonstrates an interesting area of matrix oxidation. It appears that the oxidation process did not result in formation of silica glass but rather consumed much of the matrix, leaving what appear to be the original SiC particles embedded within the first PIP cycle. Figure 65 D presents a

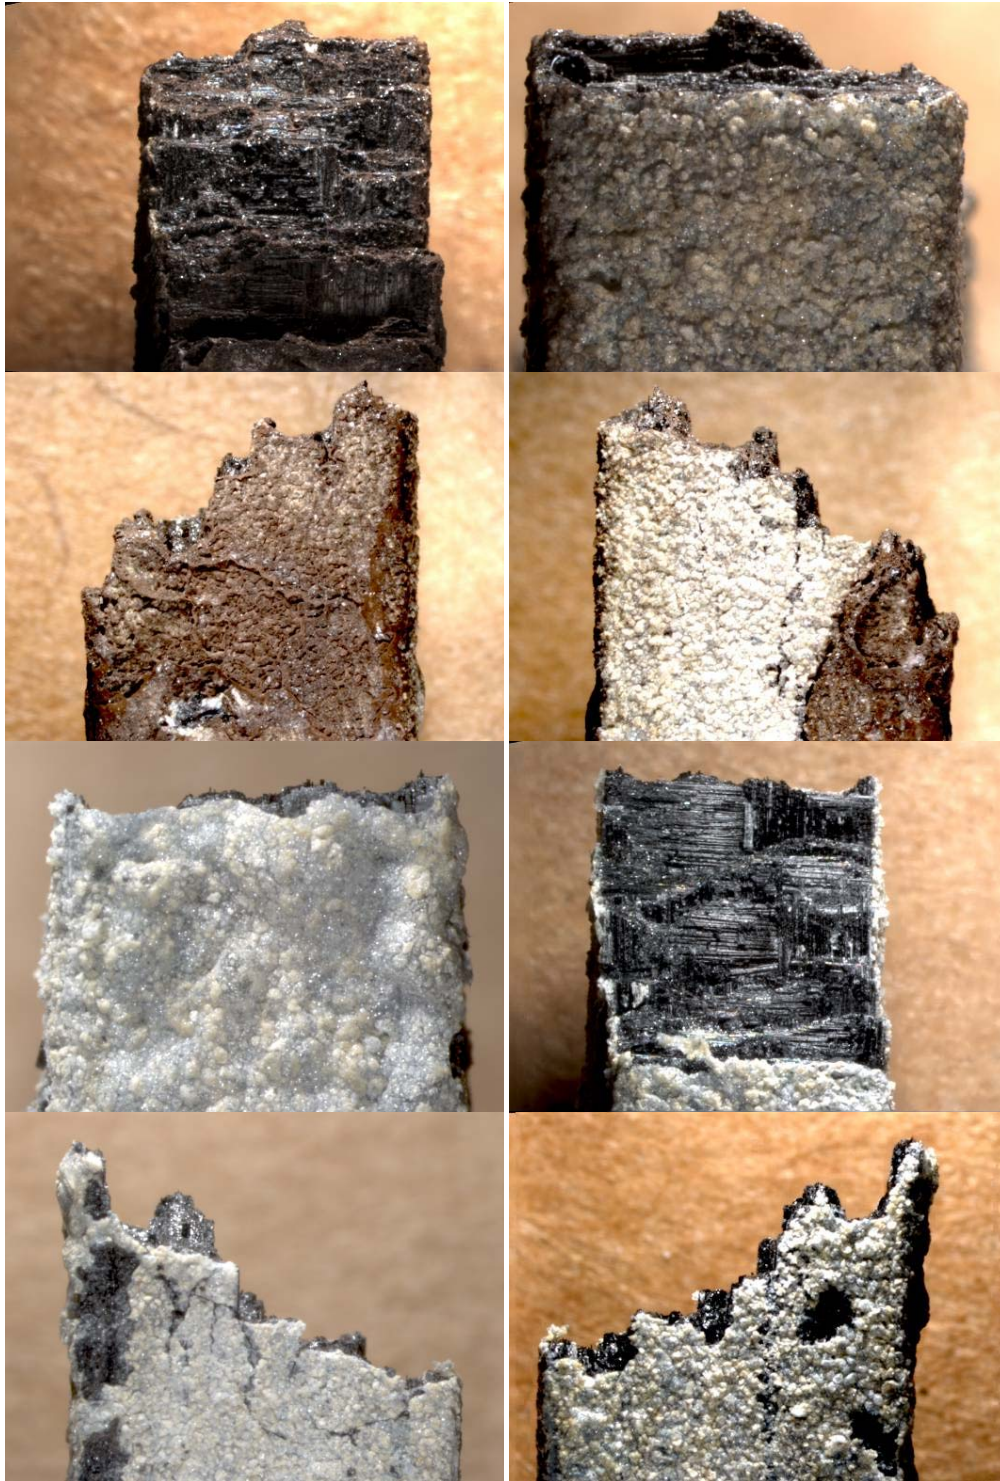
**Figure 90: Optical micrographs of specimen S11D subjected to fatigue at 1000 °C in steam ( $f = 1.0$  Hz,  $\sigma_{\max} = 70$  MPa,  $N_f = 65,154$ ). Fracture surface normal to the applied load.**
